Re: Portland Harbor Superfund Site, Portland, Oregon; Linnton Plywood Association
 Settlement Offer

LINNTON PLYWOOD ASSOCIATION – TECHNICAL EVALUATION

Upland Site: Linnton Plywood Association
10504 NW Saint Helens Road (Fig. 1)
26.5 Acres
RM 4.4 to 4.8

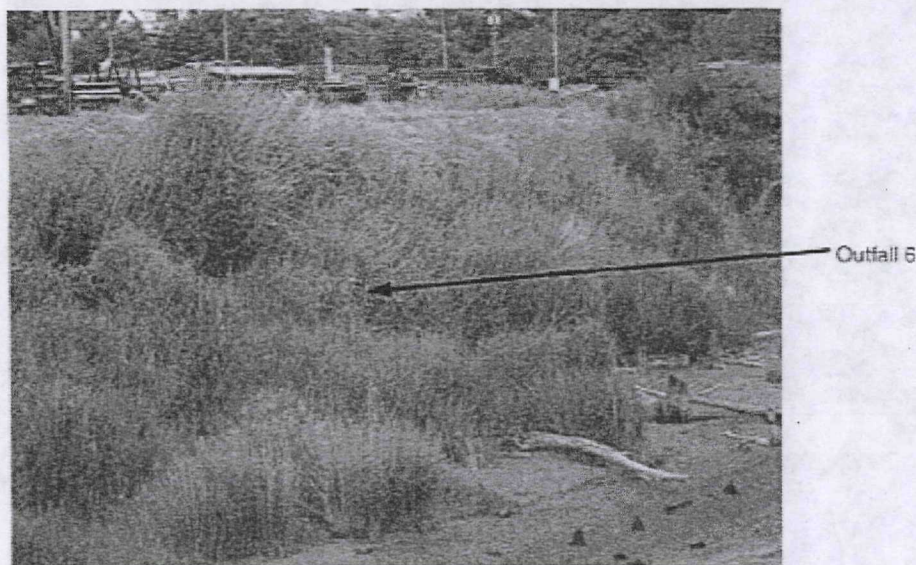
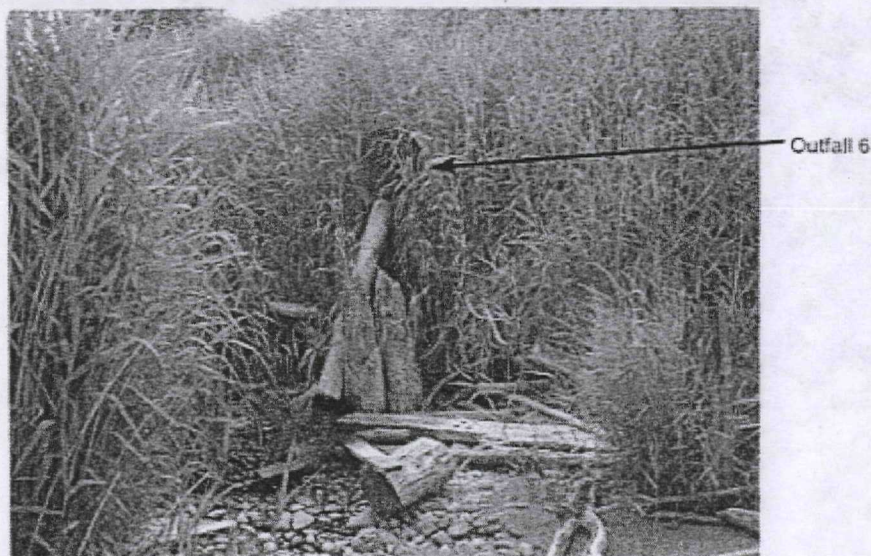
Outfall 6: The drainage basin for this outfall is the paved area on the western side of the plywood mill. Drainage basin includes pale oil application area, veneer storage area, scrubber overflow (sander dust burner), sander dust burner, contained barrel filling area, and transformers T1, T5A, T5B, and T5C; may also include railroad lines, sawdust bin, and wood waste fuel bin area. Sampling results may suggest migration of hazardous substances from the pale oil application and overflow from the scrubber used to treat the air discharge from the sander dust burner. The PAH levels detected in sediments at the discharge location of Outfall 6 may suggest a historic potential onsite source. However, as explained above, the pipeline above Outfall 6 receives storm water from upgradient and offsite sources. Accordingly, the recent closing of the facility and the cessation of pale oil application and scrubber usage eliminates these on-site sources as a potential present source and migration pathway. The outfall discharges approximately 10 feet below the paved area grade at an elevation around 16 feet MSL, close to the facility boundary. The discharge then falls an additional 10 feet to the mud flat at the bottom of the slope. Sampling shows that the following chemicals exceed screening levels for this outfall: TPH-oil, lead, zinc, and PAHs (anthracene, benzo-a-anthracene, fluoranthene, phenanthrene, and pyrene). Phenol and pentachlorophenol detection limits were too high (40-60 times SLVs) to determine whether these parameters were of concern.

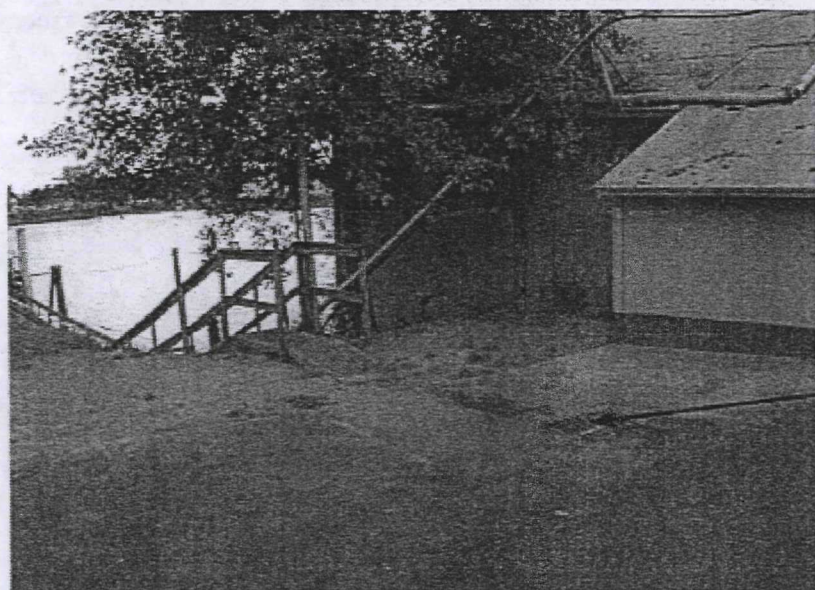
Oil Separation
Catch Basin
for Outfall 5

Outfall 5: The drainage basin for this outfall is the paved area on the northwest side of the plywood mill. Drainage basin includes auto repair shop, maintenance shop, pipe shop, diesel tank, steam cleaning area and transformer T2. The floor drain in the maintenance shop and the outdoor steam cleaning pad lead to Outfall 5. The floor drains were installed in the 1950s when the plant was converted to a plywood mill. Outfall 5 is a small-diameter pipe which discharges onto soil near the top of the bank. The outfall discharges approximately 6 feet below the paved area grade onto a vegetated slope above the 17 feet MSL facility boundary. Sampling shows that the following chemicals exceed screening levels for this outfall: cadmium, copper, lead, zinc, and bis(2-ethylhexyl)phthalate. Phenol and pentachlorophenol detection limits were too high (40-60 times SLVs) to determine whether these parameters were of concern.

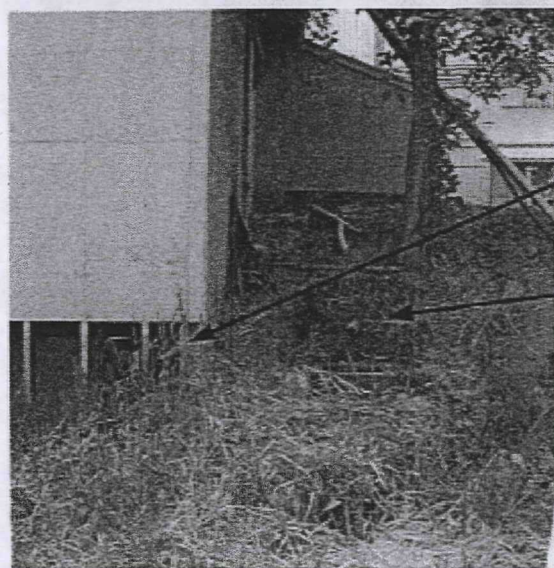
Outfall 5

Abandoned
Pipe

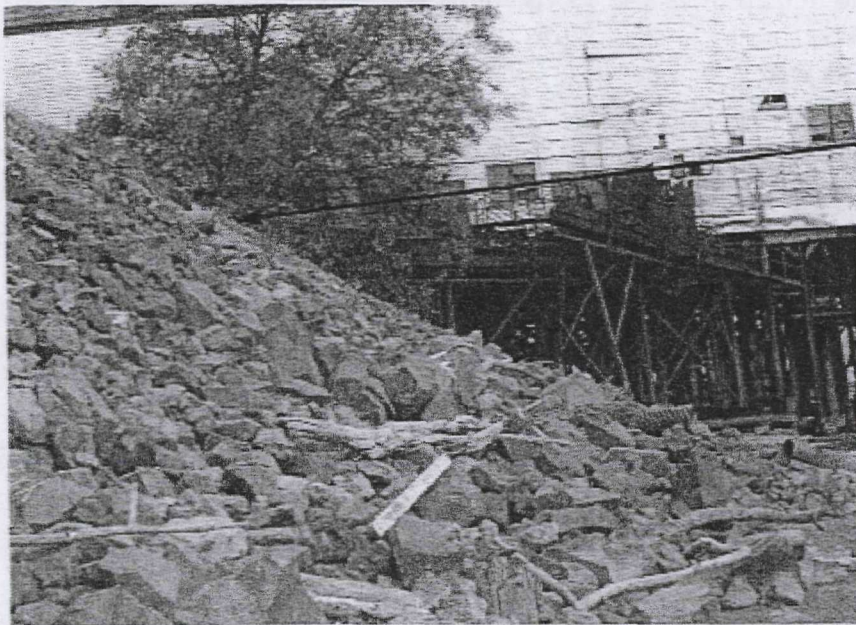
Outfall 4: Outfall 4 is located 30 feet downstream of outfall 3. This outfall drains storm water from the roofs of the plywood mill. The outfall discharges approximately 10 feet below the paved area grade onto a riprap slope above the 17 feet MSL facility boundary. This outfall was not sampled.

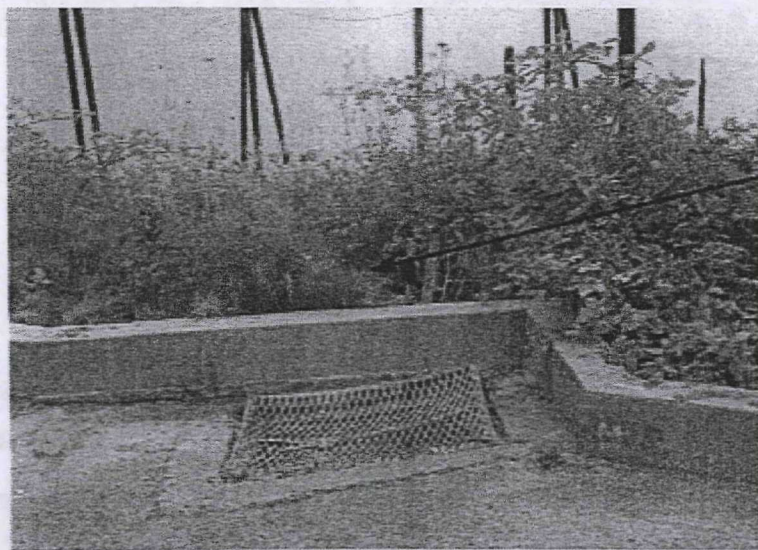
Outfalls 3 and 3A: The drainage basin for this outfall is the paved area on the southeast side of the plywood mill, west of the drainage basin for outfall 2. The outfall discharges approximately 2 feet below the paved area grade onto a riprap slope above the 17 feet MSL facility boundary. Drainage basin includes hog fuel bin, boiler house, diesel AST, caustic AST, resin AST, propane AST, oil AST, gasoline UST, and transformers T4A, T4B, and T4C. Sampling shows that none of the chemicals analyzed exceed screening levels for this outfall. Benzo(a)pyrene, phenol and pentachlorophenol detection limits were too high (40-60 times SLVs) to determine whether these parameters were of concern.

Catch basin
discharge on other
side of curb.

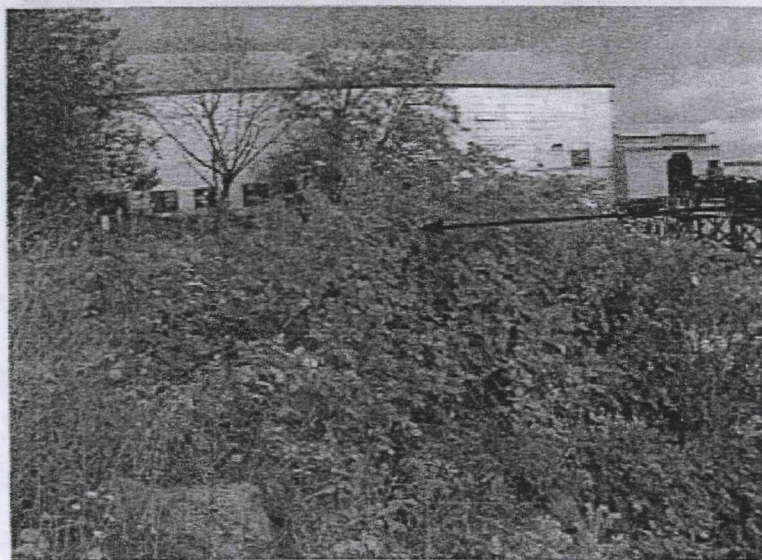
Bank below
Outfall 3.

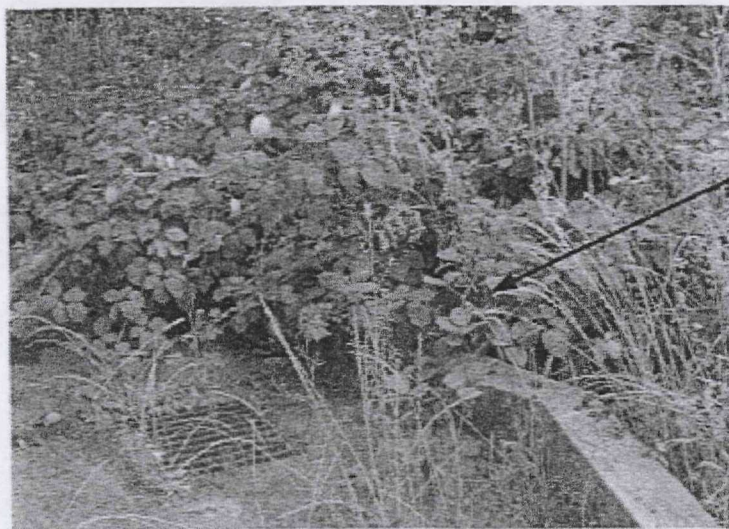
Outfall 2: The drainage basin for this outfall is the paved area on the southeast side of the plywood mill. The outfall discharges approximately 2 feet below the paved area grade onto a riprap slope above the 17 feet MSL facility boundary. Land area where sander dust ash has been placed may also drain to this outfall. Sampling shows that the following chemicals exceed screening levels for this outfall: Phenol and pentachlorophenol detection limits were too high (40-60 times SLVs) to determine whether these parameters were of concern. Sampling shows that none of the chemicals analyzed exceed screening levels for this outfall. Benzo(a)pyrene, phenol and pentachlorophenol detection limits were too high (40-60 times SLVs) to determine whether these parameters were of concern.

Catch basin
discharge on outhur
side of curb.

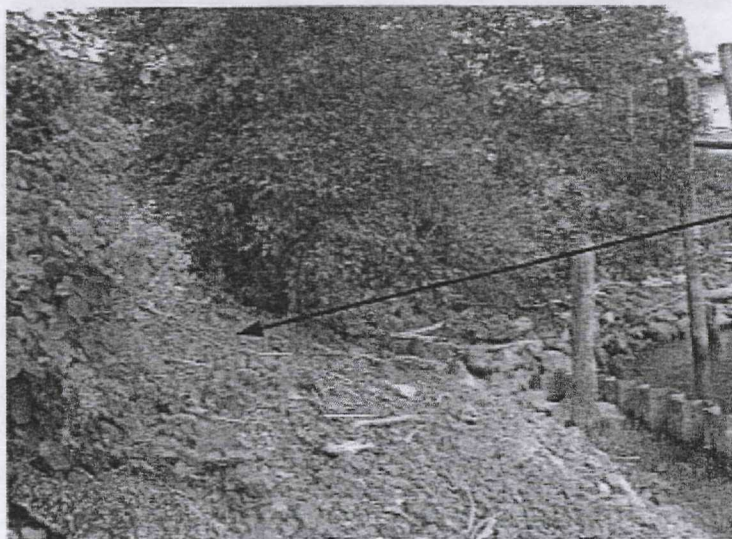
Bank below
Outfall 2.

- PAHs and dibenzofuran via bank erosion in the area of outfall 2
- PAHs and dibenzofuran via stormwater discharge through outfall 2
- PAHs and metals via stormwater discharge through outfall 5
- VOCs, selected metals, PAHs and dibenzofuran via stormwater discharge through outfall 6
